# REBUILDING THE GEAR SHIFT

Excerpt from John Deere "H" Restoration Guide  
4-9-2010

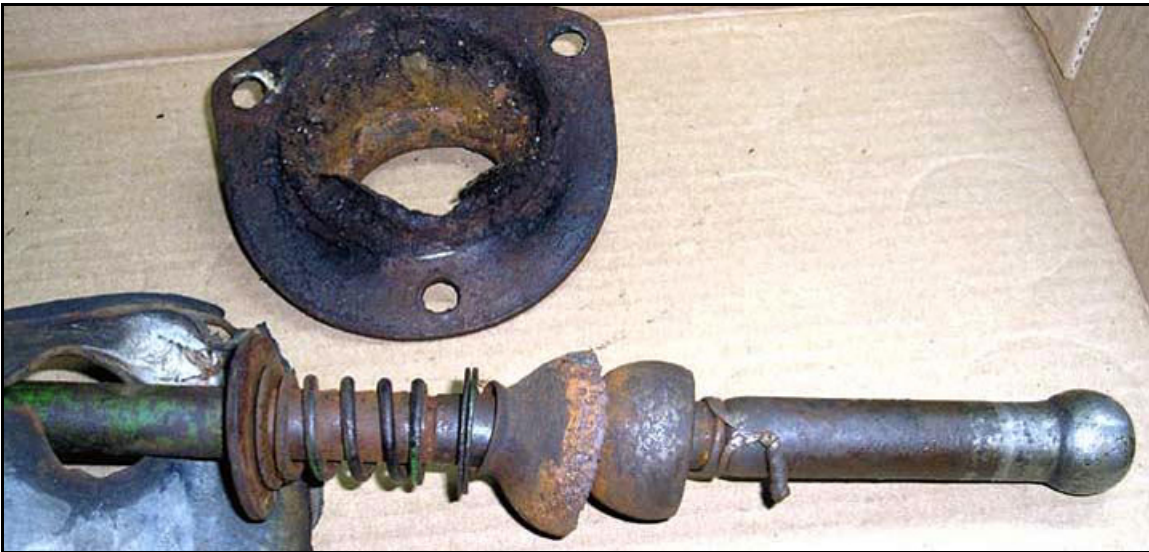
**Figure 407. A Better than Average Find!**

The initial discrepancy report item read something to the effect: "Found H378R cover (11) and H718R socket (17) rusted to Smithereens". Before it was over, nearly every item along the H722R lever (21) was replaced except the lever itself and the Handle Ball (knob) (1). Even the lever was machined some! Truly, this was a worst-case rust bucket.

Work began with PB Blaster applied, followed by a soak, then heat along with patience and persuasion for total disassembly which included removal of H717R ball (19). The ball was so deeply pitted that it was beyond recognition had it not been on the lever!

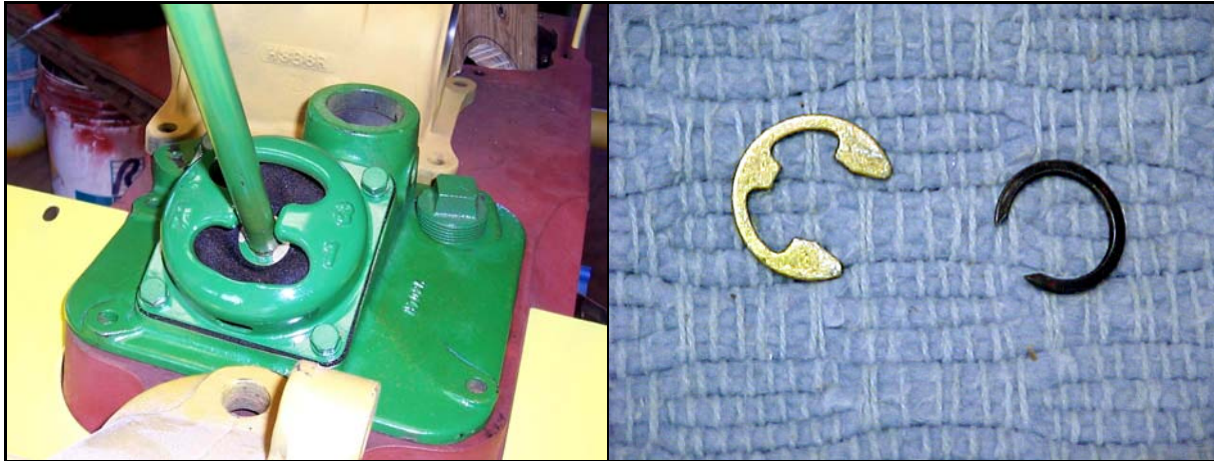
**Figure 408 (A&B). External Clip EC-62 in Use, and Compared with B387R**

On the H722R lever (21), you should find two grooves milled into the lever that are to accept B387R snap rings (3). This interface is the design weakness of this tractor's gear shifter, and of the A's and B's (1941 and up) and all the G's out there too! The snap ring, as a result of age, is no longer a good match for the groove - if it ever was. The most widely accepted work-around in the John Deere Restoring Community

is to weld a modified 5/8 inch lock washer (bent straight) in for a snap ring at the lower groove; this being just under the H717R ball for the JD "H" tractor. I am told this same fix is to be used for the upper groove as well, but I found an upper welding fix to be impractical because it makes final assembly extremely difficult. You have to have welding capability and perform final assembly at the same time, same place! And in addition, to weld an upper ring in place makes later maintenance actions much more difficult.

Rather than a second weld, a decision was made to have the upper groove slightly enhanced on a lathe. The machinist found the lever to be very tough and hard indeed! At any rate, so little was removed that it is fair to say the upper groove was "cleaned up" on the lathe. It was soon learned, however, that the B387R snap ring still would not hold even after "enhancement" of the upper groove. Some experimentation and struggle brought forth a solution in the form of a **5/8 inch External Clip**. It did the job nicely. The clip is not quite as thick as the B387R and so fits down into the lever groove much better.

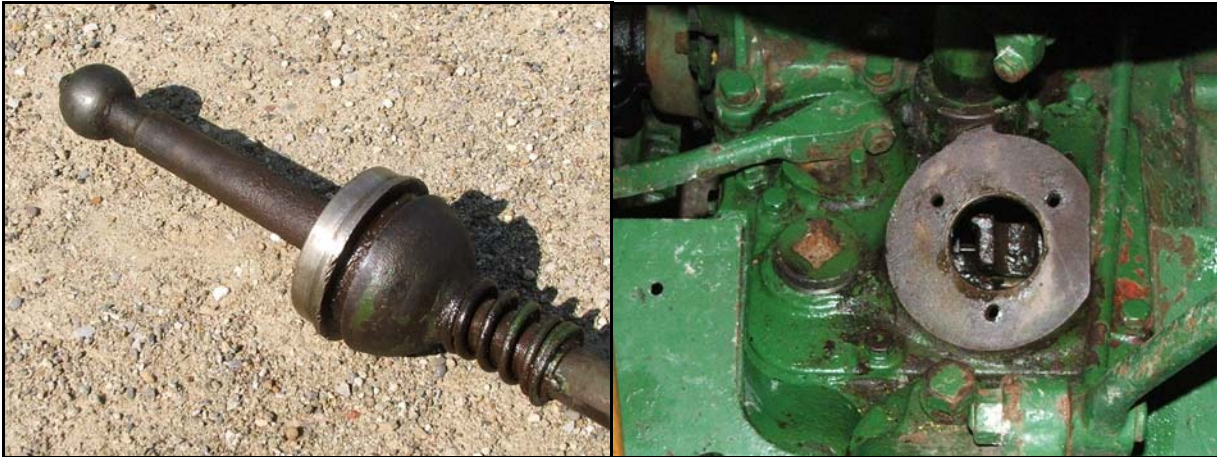
**Figure 409 (D&E). 39-H Gear Shift Assembly (left), and Transmission Cover Port (right)**

Shown in figure 4-1 (at left - above) is the transmission cover with H377R fulcrum ball socket installed. This socket is a near-press-fit into the cover, making removal a bit of a challenge. To remove the gear shift assembly, remove the F292R ball handle (The handle unscrews from the gear shift lever), and remove the three small cap screws securing quadrant. Lift quadrant away. Reinstall the F292R ball handle to assist in removal of the gear shift assembly which is not easy, and is best done by means of penetrating fluids, moderate heat, and gentle tapping and prying around the outside of the fulcrum ball socket.

Trouble with the snap rings? This is not unusual. For the bottom, it is becoming customary to spot-weld a ring in place. The ring can be an old B387R snap ring, or a 5/8" lock washer with the bend taken out of it. For the top snap ring, a few choices exist. If you are real adept with a small Dremel™ type grinding disk, you might try enhancing the groove in the gear shift lever. There is the EC-62 External Clip solution as outlined in earlier text. One enterprising fellow proposed drilling at the groove so as to insert a cotter pin (tricky at best - and may weaken the gear shift lever at a critical point).

Once inspection and repairs are completed, reinstall by reversing disassembly steps above. Ensure the fulcrum ball, its socket and cover are well treated with bearing grease during build-up. Apply a coating of Permatex 2B™ (or equivalent) to the interface of the fulcrum ball socket and transmission cover. You will note that the three holes for mounting the quadrant are not symmetrical. The quadrant piece will fit only one way. In the unlikely event the quadrant base plate breaks away from the "top hat" part, observe the "up" orientation of the base plate BEFORE welding so that its "up" direction is coincident with the "up" direction of the "top hat" part.
