# REBUILDING THE GEAR SHIFT

Excerpt from John Deere "H" Restoration Guide  
4-9-2010

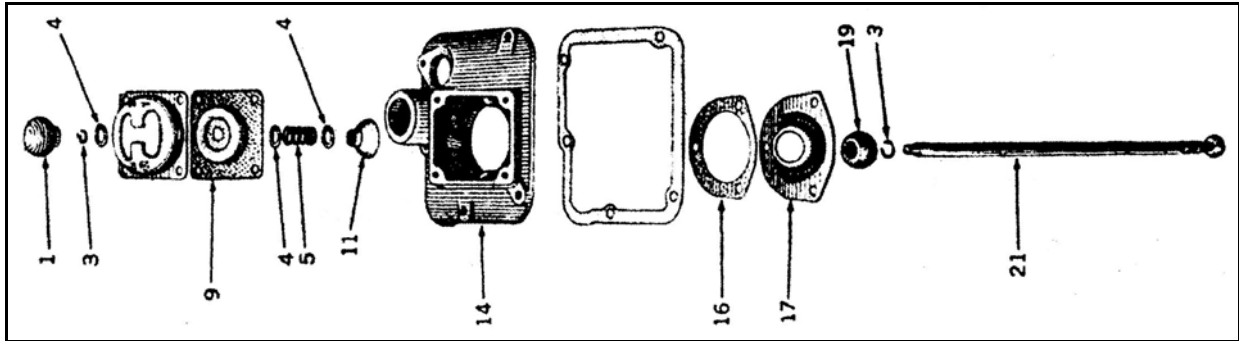
**Figure 406. The Gear Shift -- Illustration (1940 - up)**

The initial discrepancy report item read something to the effect: "Found H378R cover (11) and H718R socket (17) rusted to Smithereens". Before it was over, nearly every item along the H722R lever (21) was replaced except the lever itself and the Handle Ball (knob) (1). Even the lever was machined some! Truly, this was a worst-case rust bucket.

Work began with PB Blaster applied, followed by a soak, then heat along with patience and persuasion for total disassembly which included removal of H717R ball (19). The ball was so deeply pitted that it was beyond recognition had it not been on the lever!

On the H722R lever (21), you should find two grooves milled into the lever that are to accept B387R snap rings (3). This interface is the design weakness of this tractor's gear shifter, and of the A's and B's (1941 and up) and all the G's out there too! The snap ring, as a result of age, is no longer a good match for the groove - if it ever was. The most widely accepted work-around in the John Deere Restoring Community

is to weld a modified 5/8 inch lock washer (bent straight) in for a snap ring at the lower groove; this being just under the H717R ball for the JD "H" tractor. I am told this same fix is to be used for the upper groove as well, but I found an upper welding fix to be impractical because it makes final assembly extremely difficult. You have to have welding capability and perform final assembly at the same time, same place! And in addition, to weld an upper ring in place makes later maintenance actions much more difficult.

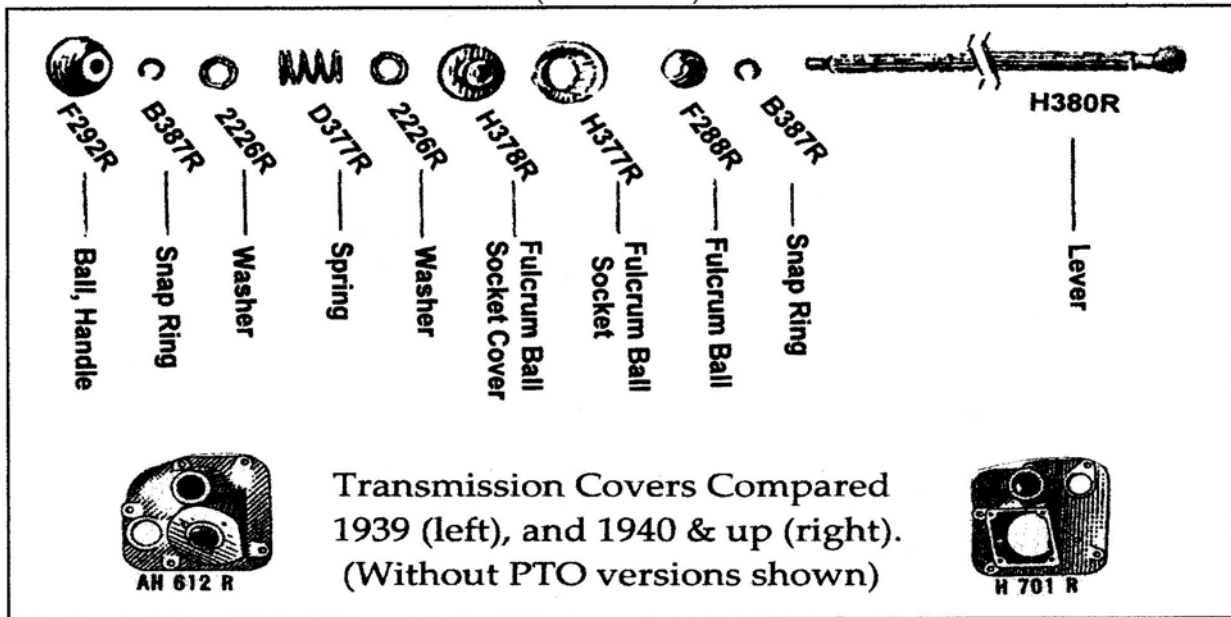
**Figure 409C. The Gear Shift Illustrated - 1939**

Shown in figure 4-1 (at left - above) is the transmission cover with H377R fulcrum ball socket installed. This socket is a near-press-fit into the cover, making removal a bit of a challenge. To remove the gear shift assembly, remove the F292R ball handle (The handle unscrews from the gear shift lever), and remove the three small cap screws securing quadrant. Lift quadrant away. Reinstall the F292R ball handle to assist in removal of the gear shift assembly which is not easy, and is best done by means of penetrating fluids, moderate heat, and gentle tapping and prying around the outside of the fulcrum ball socket.

Once inspection and repairs are completed, reinstall by reversing disassembly steps above. Ensure the fulcrum ball, its socket and cover are well treated with bearing grease during build-up. Apply a coating of Permatex 2B™ (or equivalent) to the interface of the fulcrum ball socket and transmission cover. You will note that the three holes for mounting the quadrant are not symmetrical. The quadrant piece will fit only one way. In the unlikely event the quadrant base plate breaks away from the "top hat" part, observe the "up" orientation of the base plate BEFORE welding so that its "up" direction is coincident with the "up" direction of the "top hat" part.
